Manhole Inspection Summary

Manhole # S150__003MH

Insp Date: **3/27/08 12:28 PM**

Location Address: **2643 DULANY ST**

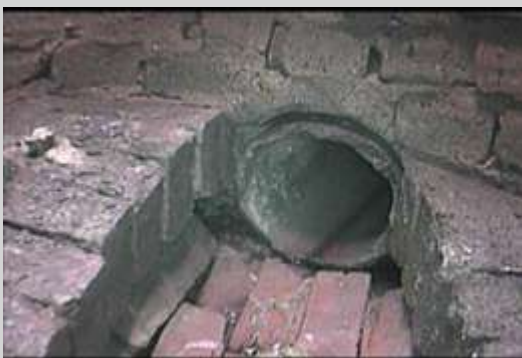
8 O'Clock Inflow

6 in. Circular Gravity Sewer
Pipe In @ 8 O'Clock

Pipe Height: **6** (in.) Rod and Bar (Angled)
Pipe Material: **Clay** ☐ Pipe Lined
Invert Depth: **6.25** (ft.) Flow Characteristics: **None**
Deposits: ☒ **None** ☐ Mud ☐ Sludge ☐ Debris ☐ Grease
Silt Depth: **0** (in.) Deposits Extent:
Infiltration: **None** Pipe Seal Cond: **Sound**
